Conservatories – Take Time To Avoid Misalignment Problems

When specifying and installing a conservatory you have to ensure that the perimeter frames are not only laterally and diagonally correct but are also plumb and level, writes Don Waterworth - or misalignment will be the consequence

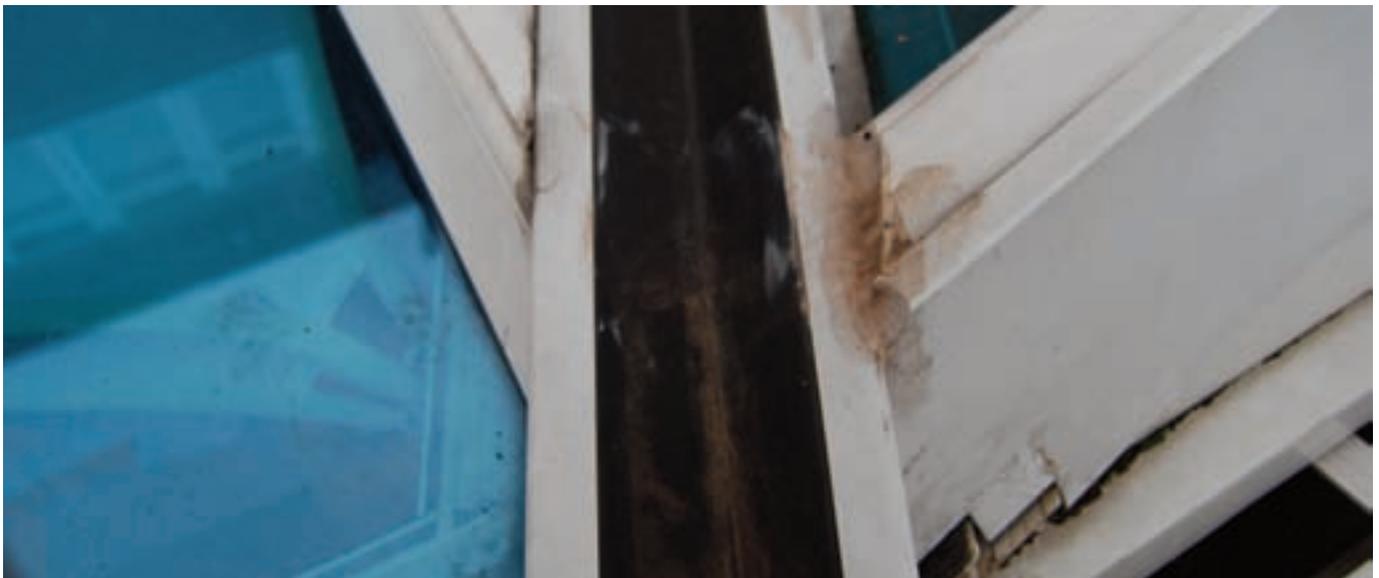
The attached Photograph shows a jack rafter which has been filled with silicone due to the perimeter frames of the conservatory (L shaped on plan), being misaligned.

This was the case with this conservatory in Essex that I inspected.

The perimeter frames and hence the roof, were so misaligned that not only were many of the rafters and jack rafters siliconed in place but also a number of the d/g segmented units at the valleys above the front pike were misaligned and indeed short, allowing extensive water ingress to

enter the conservatory.

In fact, the conservatory was flooded internally on a regular basis. The upshot was that the roof had to be removed and replaced.

Prior to these works, the perimeter frames had to be suitably re-fixed and realigned. It cost the installer all the profit and more on top along with reputational damage.

So make sure your installers are made aware of the importance of correct perimeter frame alignment as the consequences can be very costly. [i](#)
