Correct Shimming Of Bay Windows

I recently carried out a structural survey of a detached 1930s property and noted immediately that the front bay windows had not been installed and shimmed correctly, writes Don Waterworth.

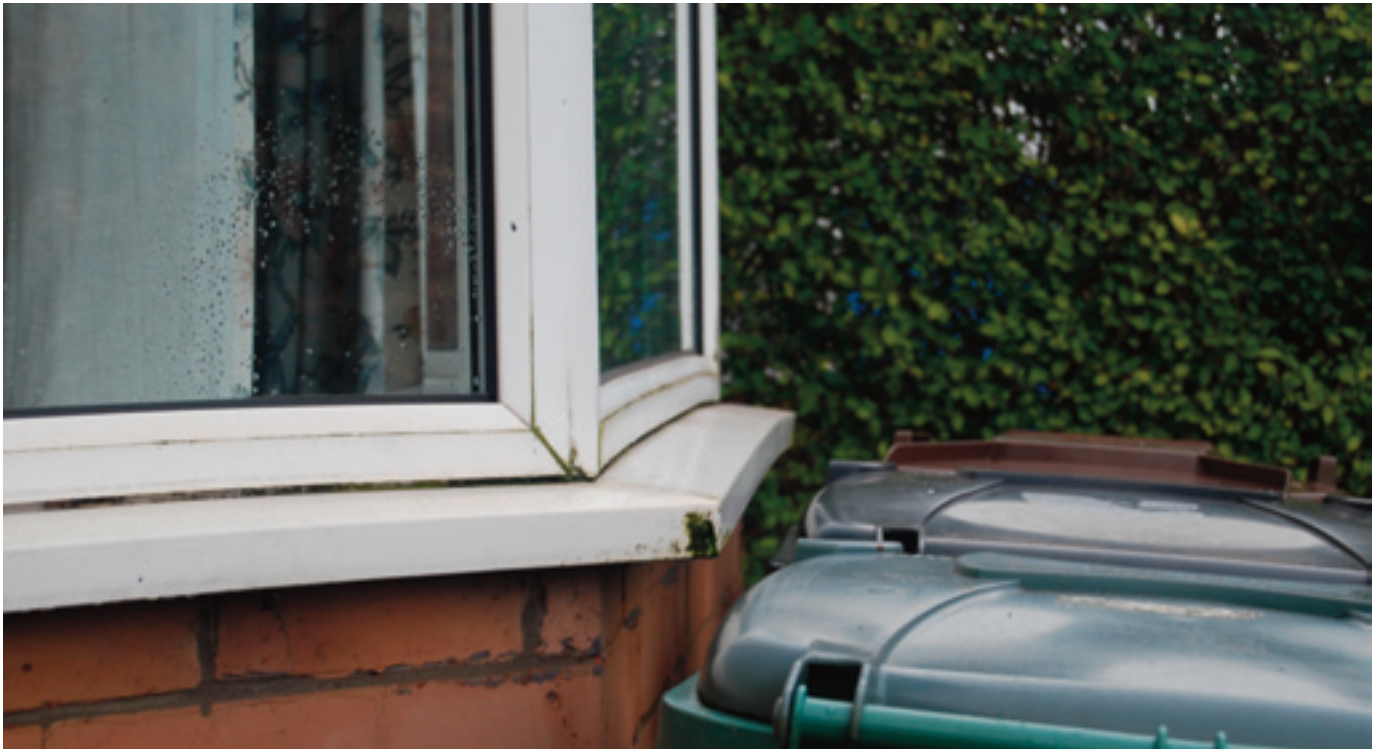
Nowadays, the screw down jacking systems should avoid the defects seen in this photo, writes The Installer's technical and legal expert, Don Waterworth. Nevertheless, you need to be aware of what can happen if loads are not suitably supported and what that might cost your reputation.

To be fair the bay window in the picture was fitted over 20 years ago when many window companies did not understand the loading of bays.

However, I think it is important to show not just the typical distortion caused by the corner posts, which have bowed the cill but also above this bay the brick rendered section had obviously settled and pulled away from the main structure due to eccentric loading. So, it is not a mere or normal task to support bay windows properly, it is vitally important if structural damage is to be avoided.

As you are probably all aware, the correct shimming of the ground floor bay head between the frame and the head plate is incredibly important.

It is also necessary to ensure that the cill corners where the bay poles sit, are correctly filled to take the implied loads, passing down through the bay poles.

Nowadays, the screw down jacking systems should avoid such defects, nevertheless you need to be aware of what can happen if the loads are not suitably supported. **f Don.**
