Iron Men Leave Legacy To Trip You Up

There are still so many MS angle iron lintels out there in the UK's domestic property portfolio causing damage as they expand because of water ingress writes The Installer's technical author Don Waterworth of Hanley Amos Stewart. And they are ready to cause problems for the unsuspecting (or unsavvy) Fenestration Surveyor that fails to point prospective defects out to the householder.

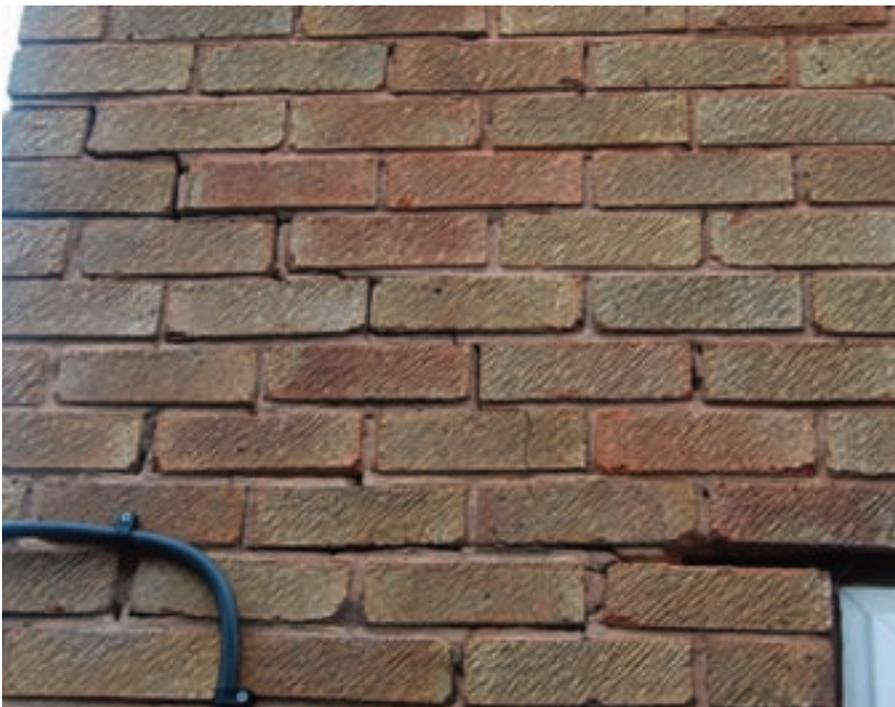
Photograph

Surely a Professional Surveyor or Architect should understand that rainwater penetrating the outside skin could easily attack this MS lintel and due to the section of the steel, usually 10 or 12mm thick, the steel would start to expand. The consequence of this bad design (often only manifested on South or West facing elevations, which take the brunt of the UK wind and rain), was extensive expan-

sion in some cases of the lower leg of the lintel. I have been to properties where an angle iron lintel has lifted the brickwork above with cracks so wide that I could fit my fingers in.

The photo shows typical expansion of an MS angle iron lintel with the crack running up from the top left-hand corner of the aperture. However, as this aperture sits within a metre or so of the corner, this weak section of masonry has allowed the crack to continue around the corner, opening up to 6-8mm wide.

Picture: A typical expansion of an MS angle iron lintel with the crack

Therefore again, as Fenestration Surveyors, be wise to any existing defects and be professional by explaining the sequence of events that can lead to this problem...and suggest a practical solution.

N.B. Do not forget to write down on your Survey Sheet that you have advised the householder and take a photograph. **Don**
