Don't Let A Drain Become A Pain

If you plan to build a conservatory over a drain, make sure you do the right checks as putting things right after can be an expensive business writes Don Waterworth, The Installer's technical author.

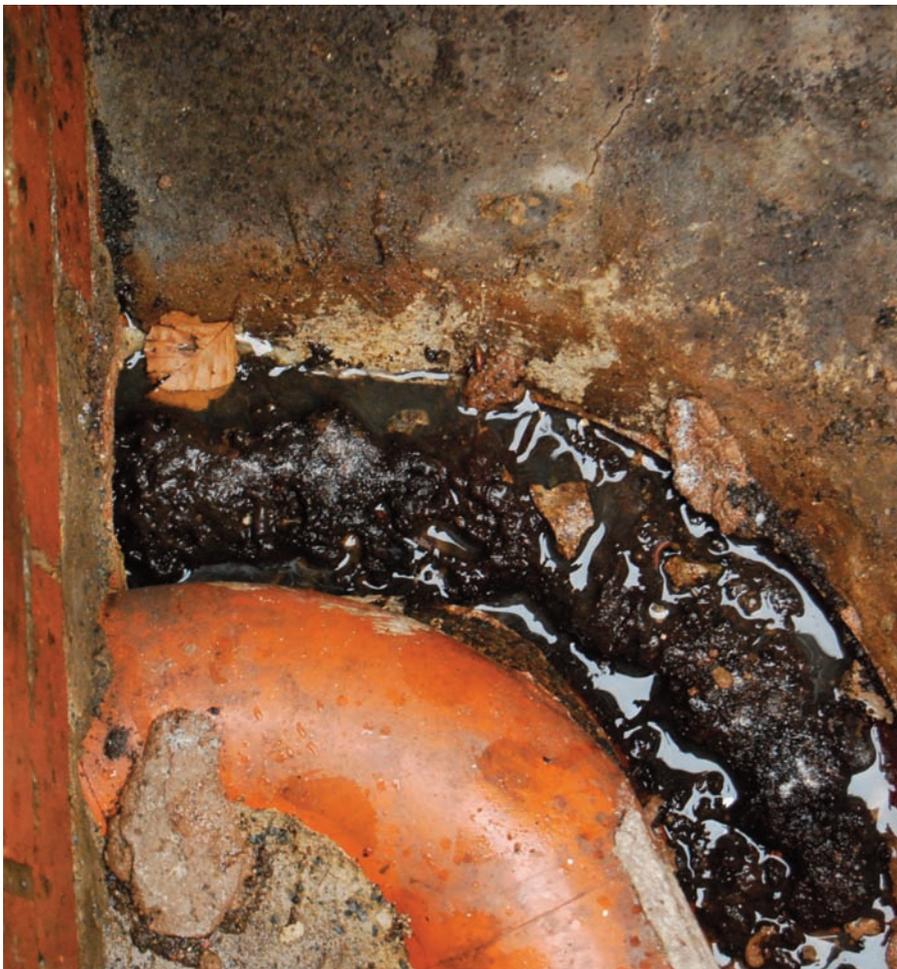
The picture here shows a blocked drain which runs under a conservatory wall which was found to have no drain protection in place, causing the vitreous clay drain to fracture and crush, causing a blockage.

The responsibility for these repair works would fall squarely on the shoulders of the conservatory company. Should the failure of the drain run be partly under the slab, then the cost could be prohibitive and certainly be in the thousands rather than in the hundreds of pounds. Therefore do not assume that you can simply send your subcontract builder to carry out substrata works without inspecting these works, for if the foundations, masonry or in this case drain protection, are not carried out properly, then you will suffer the consequences. **i**

Picture: A blocked drain which runs under a conservatory wall was found to have no drain protection in place.
