# Reviving Historic Lantern Domes

**Within the project, the trio of shallow domed steel lanterns on an upper mezzanine level presented one of the most difficult challenges, both in terms of technical difficulty and logistical constraints.**

Led by the client's agent, Avison Young and main contractor McLaren Construction, the conversion of 214 Oxford Street at the North-East quadrant building on Oxford Circus has seen it turned into a flagship store for Ikea.

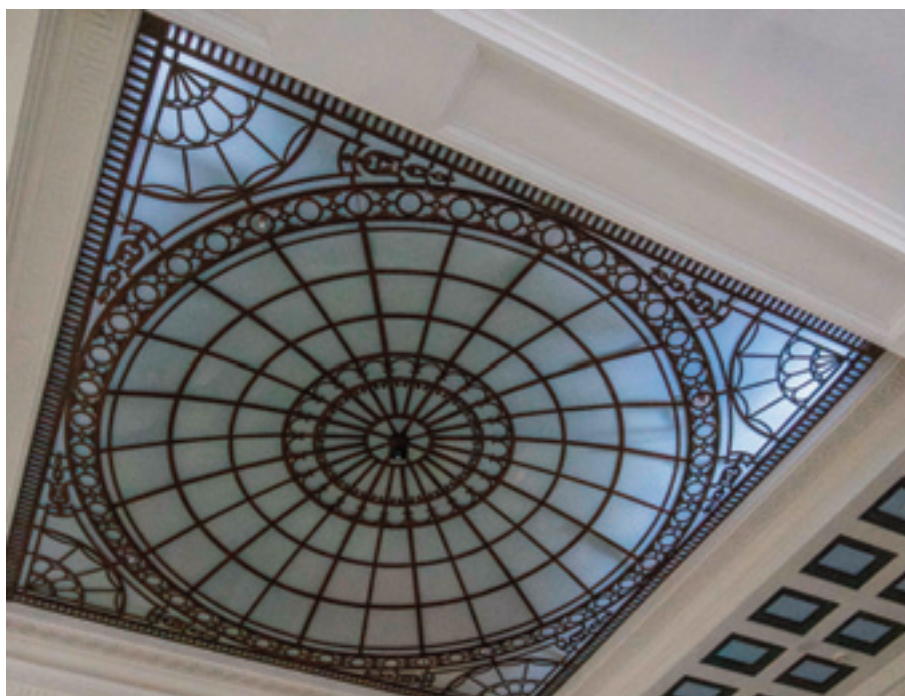
**Window repair specialist, ASWS, brought its skills to bear during a two-year refurbishment contract addressing one of London's best known retail landmarks – the Ikea store at Oxford Circus.**

The senior site manager for McLaren, Jack Wright, said: "As part of the refurbishment we needed to introduce temporary works to re-support the dome steel whilst we removed the supporting framework and carried out glazing replacement. The glazing then had to be brought back up to modern safety standards.

“Every piece of glass had to be templated in plywood and sent away to be remade, before being reglazed in a traditional manner and eventually repainted. It was a very tight space for staff to work in, making it logistically difficult. As part of the pricing, ASWS worked closely with McLaren to establish a robust glazing replacement methodology, which included erecting a seven-metre-high scaffold off the slab below, sequenced so that all the different levels of the dome could be accessed as necessary.”

Working from the ‘birdcage’ scaffold, the first task for ASWS was to demount the 148 panes of glass from each dome and meticulously remove the encrusted dirt and lead paint so that the true condition of the steel could be determined. Over a two-week period, every fractured joint was carefully rewelded while any seriously damaged sections were replaced to ensure the whole assembly was stabilised.

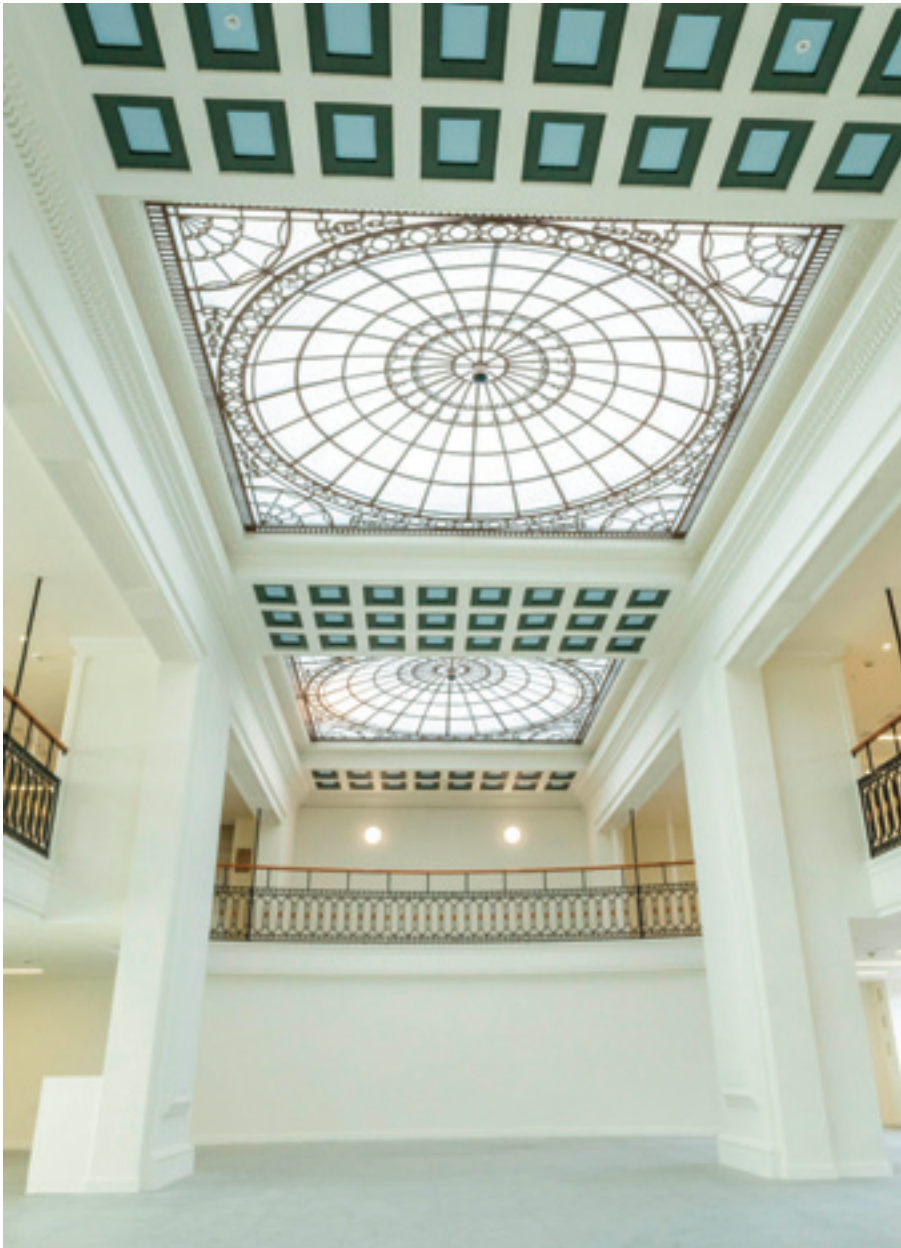
Pictured are two of the three intricate circular domes ASWS refurbished as part of the project.

Importantly, the reinstated lanterns and their new safety glass feature authentic rebates and edge details, while all the steelwork has received the new five-coat treatment that ASWS

utilises on most projects. Involving a full primer and two undercoats as well as two topcoats, both internally and externally, this redecoration strategy offers the best standard of adhesion and finish possible for in-situ treatment.
