Conservatory Condensation – Better Insulation Solves the Problem

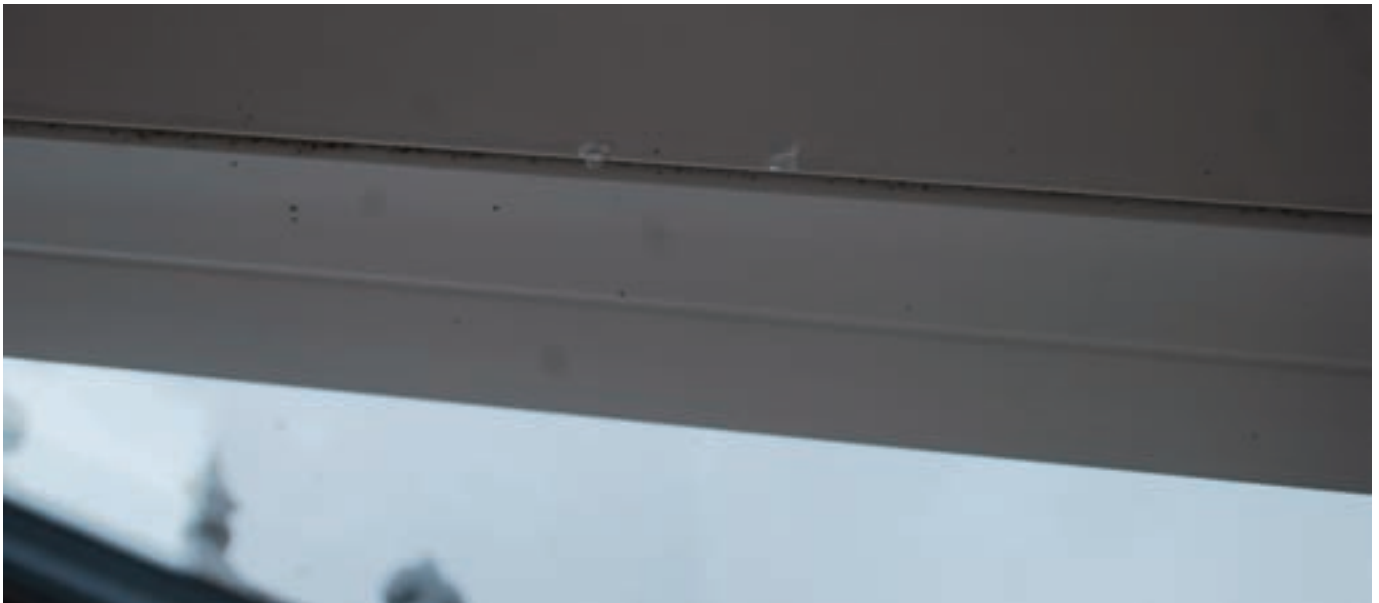
The photograph shows 2 drops of water on the underside of a valley.

The outside temperature is 6°C, inside temperature 15°C or so and the basic principle occurring here is that warm air from the in-

side of the conservatory, is meeting the cold metal of the valley.

When this occurs, 'dew point' can be reached and condensation is formed.

The solution is to make sure that metal elements where possible are insulated and of course, routinely the aluminium elements of a conservatory roof are not insulated and therefore you can find yourself attending a property to appease an irate consumer. In reality you have done nothing wrong.

There are suppliers that supply a 2mm thick adhesive foam tape which you can stick to the underside of box gutters and valleys. In my experience this doesn't perform very well at all and what is really required is an insulation method which incorporates a vapour barrier.

The benefit of this is that the warm air cannot rise up and meet the cold metal as the vapour barrier and the insulation are providing a suitable barrier.
