Saying No To Nose Board Boggles And Water Staining

This article is by our technical writer – Principal Surveyor Don Waterworth of hanleyamosstewart.co.uk

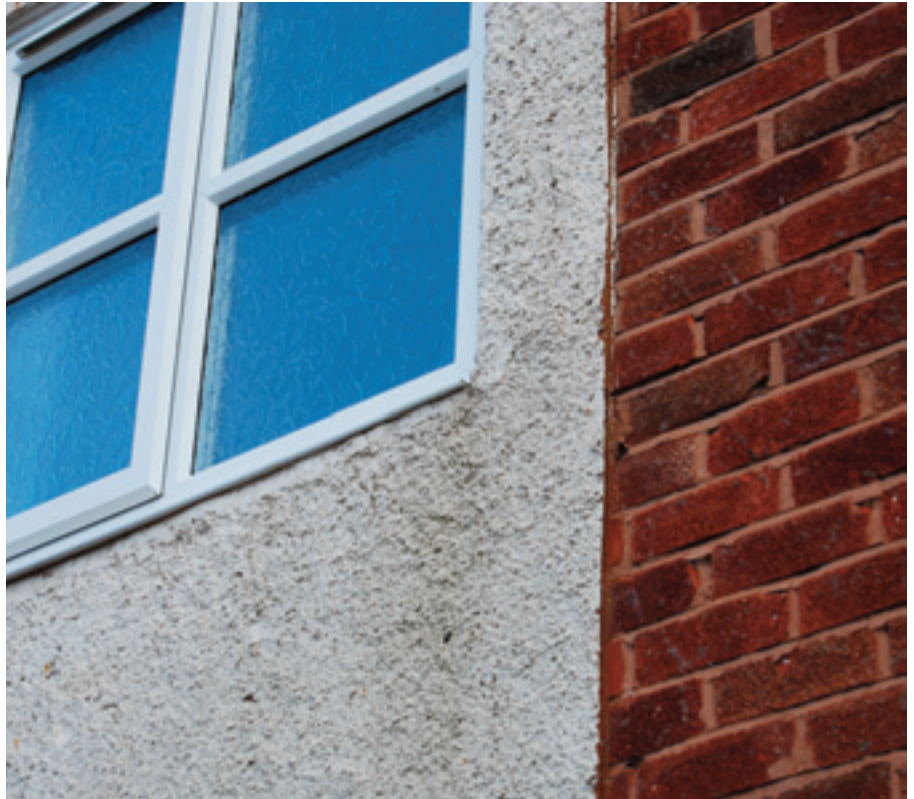
Take a look at this appalling job – not only does the ‘cill’ not project the minimum of 25mm, it is also made from the nose section of a fascia board. With no projection and no capillary groove to draw water away, there is no surprise there is staining on the walls and an angry customer looking up at them.

This photo shows a bathroom window recently installed which was clearly measured incorrectly on height, writes Don Waterworth.

And The mis-measurement meant the installer could not, it would appear, fit the projected cill as provided by the manufacturer. He decided instead to place a nose section of a fascia board under the window to form a cill.

This is absolutely unacceptable. In the first instance the projection of a minimum of 25mm has not been met. Secondly, as the

nosing is not designed to perform as a cill, there is no capillary groove to the underside to ensure that the water drips away from the elevation.

The result is, you will note, some water staining to the bottom right hand corner, which after only a matter of months is starting to stain more of the rough cast render.

Whether your fitting windows, doors or conservatories, you must remember to achieve the correct projections to ensure that water runs away from the building rather than against the building which can lead to water ingress and problems for you – which could be costly. **■ Don.**
