# Avoid Bridging Damp Proof Courses

It is vitally important that you ensure that your sub-contractor is not bridging a Damp Proof Courses (DPC) with the external works says our technical expert, Don Waterworth.

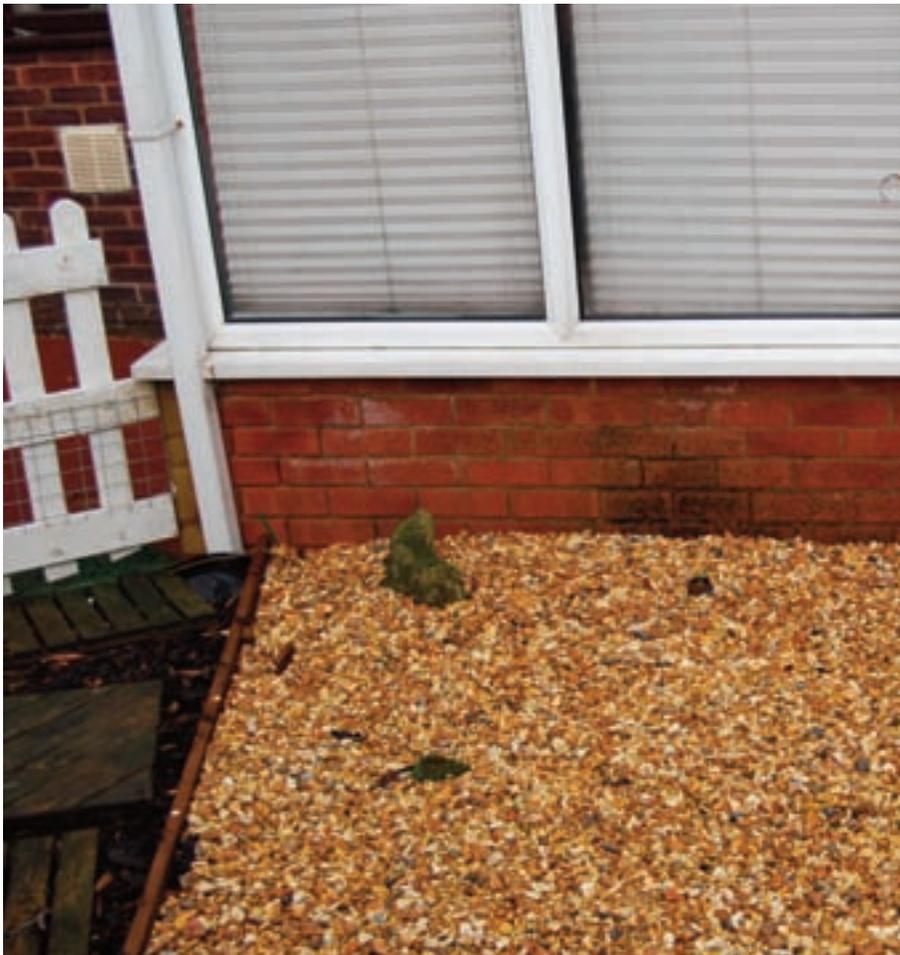
## Picture:

The Building Regulations and Good Building Practice state that, any external ground level should be 150mm below the DPC. The reason for this is that moisture running towards the property or sitting close to or above the DPC,

can bridge the DPC and cause internal dampness to the internal fabric, which will give you an irate customer and remedial costs.

Take a look at the image, this was a conservatory that had been completed then landscaped to include for the pebble finish that can be noted in the photograph. Unfortunately, the contractor had clearly not understood

the need to avoid bridging the DPC - the finish level of the pebble finish was approximately 125mm above the course!

This was a conservatory that had been completed then landscaped to include for the pebble finish which was approximately 125mm above the DPC.

Therefore in this situation, should the landscape chap been brought in by your company, then you are liable for the actions of your sub-contractors and would need to rectify this problem. I inspect many instances where sub-contractors have made a mess of works and cost the main contractor a fair sum of money. You must always pursue any sub-contractors that you have employed which do not come up to the mark and whose actions cost you money to rectify.
