Technical Article

Written by Don Waterworth BSc (Hons)
FCABE MEWI Chartered Building Engineer /
Building Surveyor, Expert Witness,
Accredited Mediator – Tel: 0800 1954922

Angle Iron Lintels – Hazards Await The Unwary

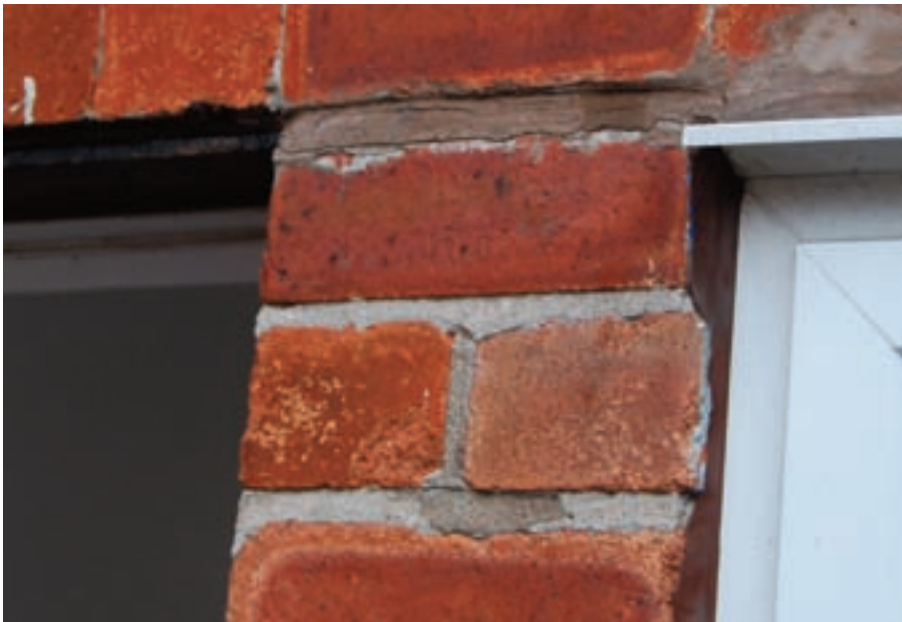
The main problem with angle iron lintels is once they have been fitted for some years, they can start to expand. This is par-

ticularly troublesome on South or West facing elevations and/or where the bricks are porous. Trouble could occur where the angle iron lintel, which of course is mild steel, starts to expand due to the rainwater moisture penetrating through the outer skin brick and mortar and comes into contact with the mild steel. This expansion can cause 'jacking up' of the brickwork and therefore you should be aware of this when you are installing windows and the householder should be informed ideally.

Any angle iron lintels in situ should be replaced for a Catnic CN7 or an IG lintel and certainly where angle iron lintels have started to expand. Make sure that you cover yourself by taking photographs and by advising the householder if a lintel is defective, that the expansion will more than likely continue - thus you cover against any liability for future repairs.
